MILL CREEK DAM

NDI I.D. PA-0038

PHASE I INSPECTION REPORT
NATIONAL DAM INSPECTION PROGRAM

NAME OF DAM: Mill Creek Dam
STATE LOCATED: Pennsylvania
COUNTY LOCATED: Bradford
STREAM: Mill Creek, a secondary tributary of Susquehanna River
SIZE CLASSIFICATION: Small
HAZARD CLASSIFICATION: Significant
OWNER: Camp Spring Hill, Inc.
DATE OF INSPECTION: November 14, 1980 and February 5, 1981

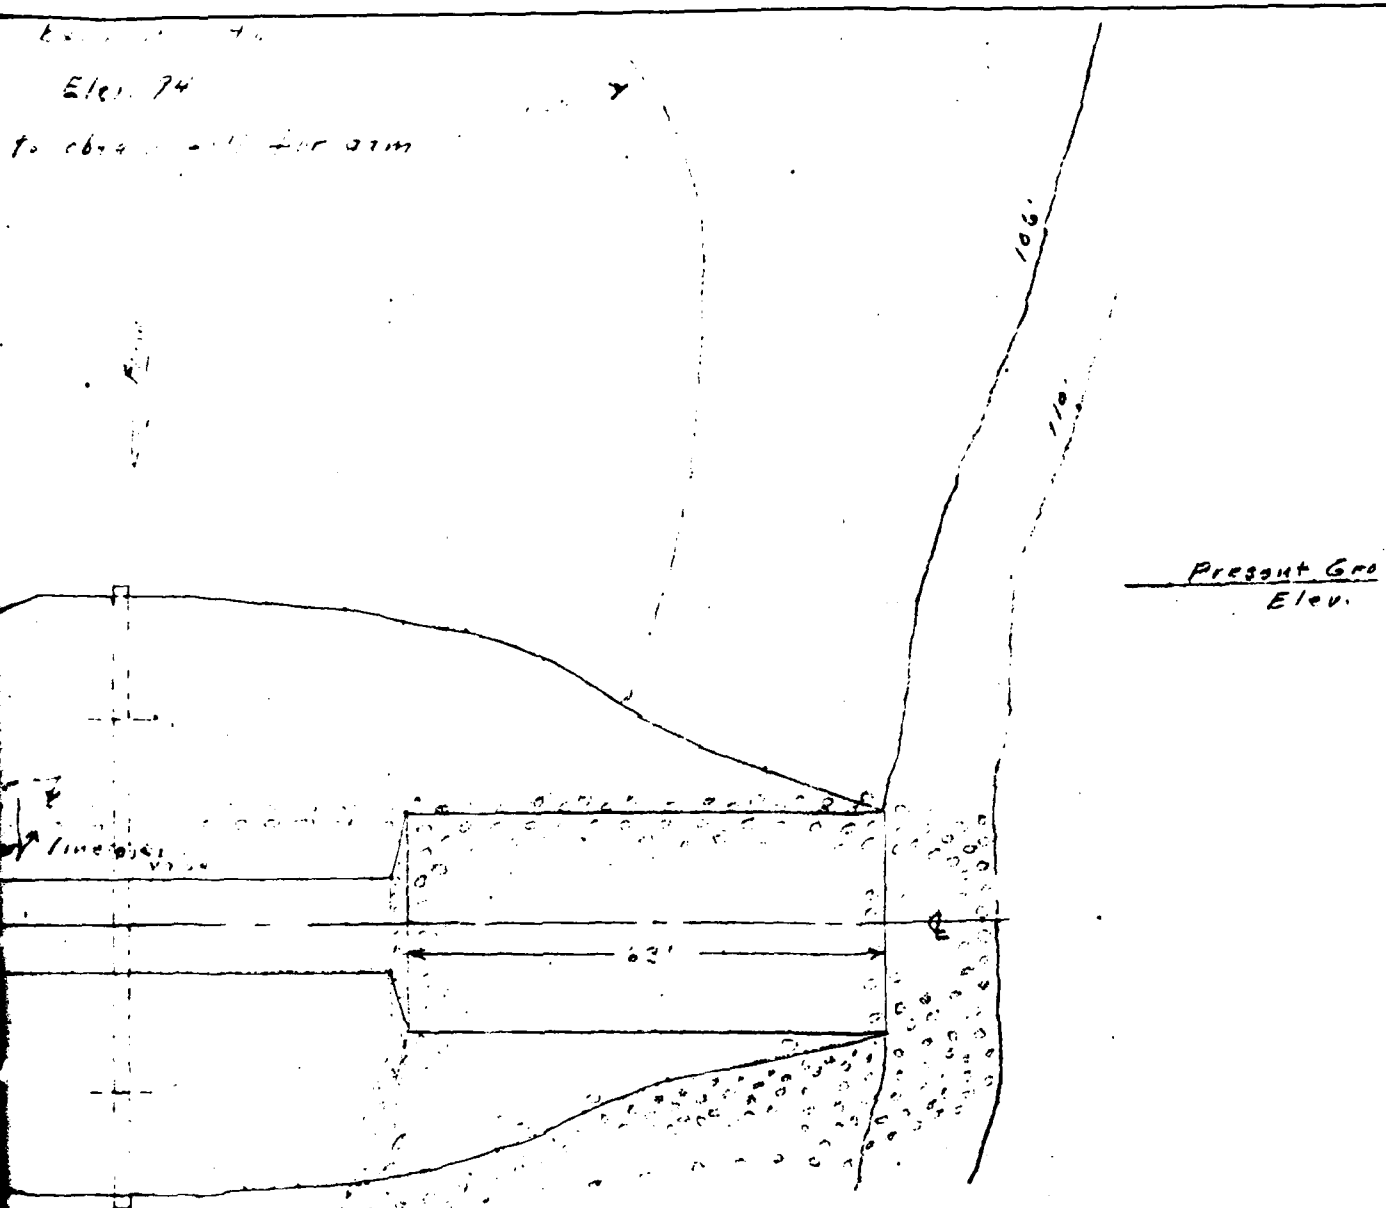
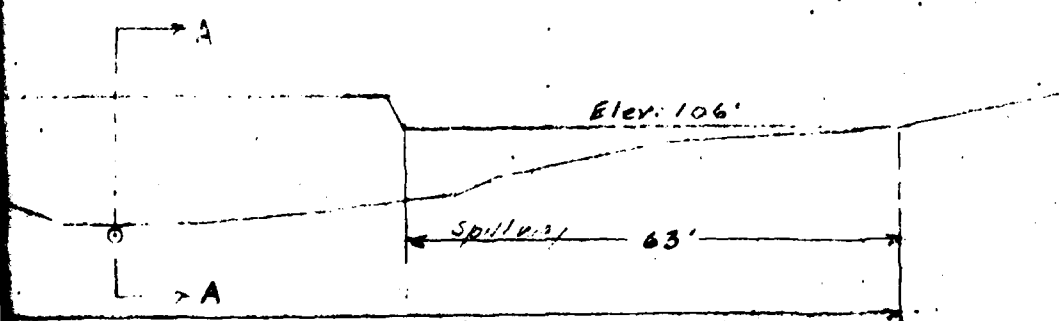
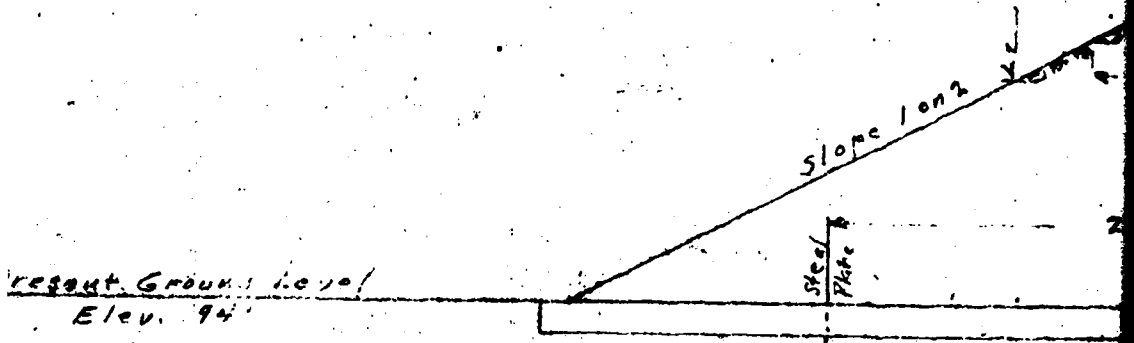
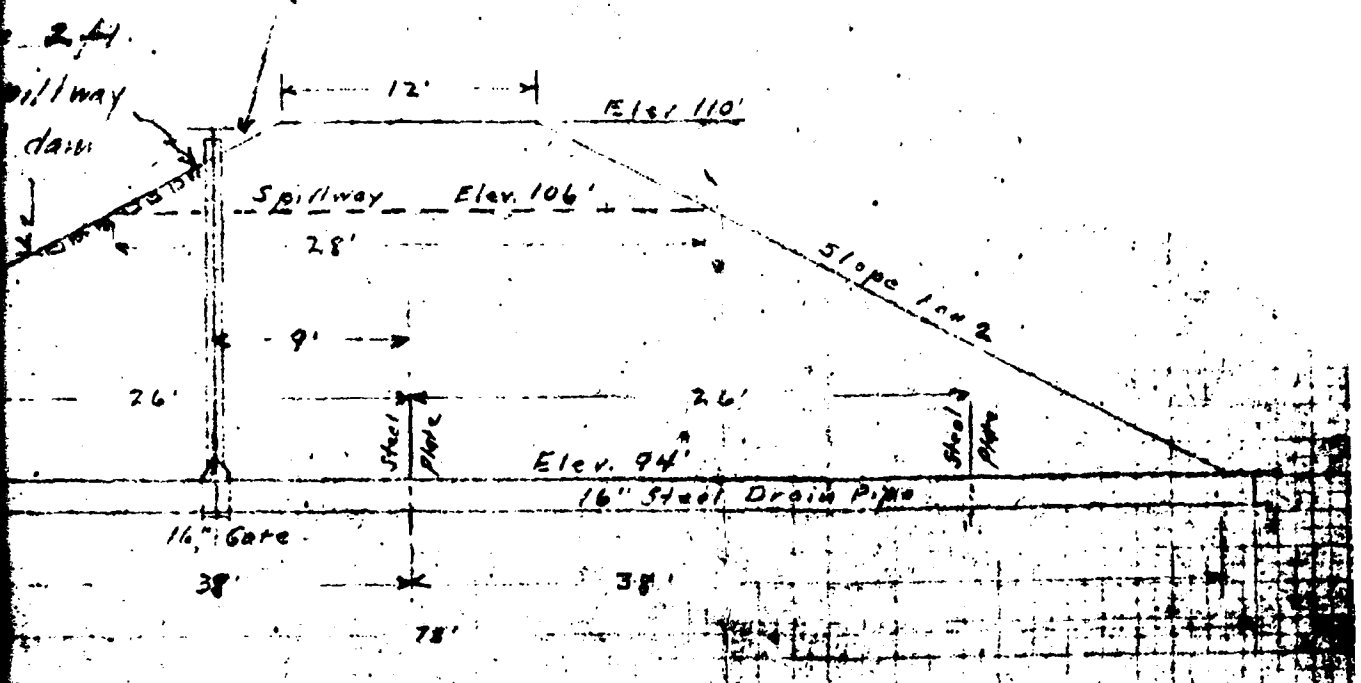
PLATE 2

(1) Embankment. Available records indicate that the dam consists of a compacted homogeneous earth embankment. Plates 2 and 3 show the plan and the typical cross section of the dam, respectively. The dam was designed to have a 2 horizontal to 1 vertical slope both upstream and downstream with a crest width of 12 feet. Riprap was provided on the upstream face extending from about two feet below the normal pool level to about two feet above the normal pool level.

Plate 2 also shows the plan and valley cross section of the dam. As shown in Plate 4, approximately a 60-foot section of the embankment forms the base of the open channel spillway.

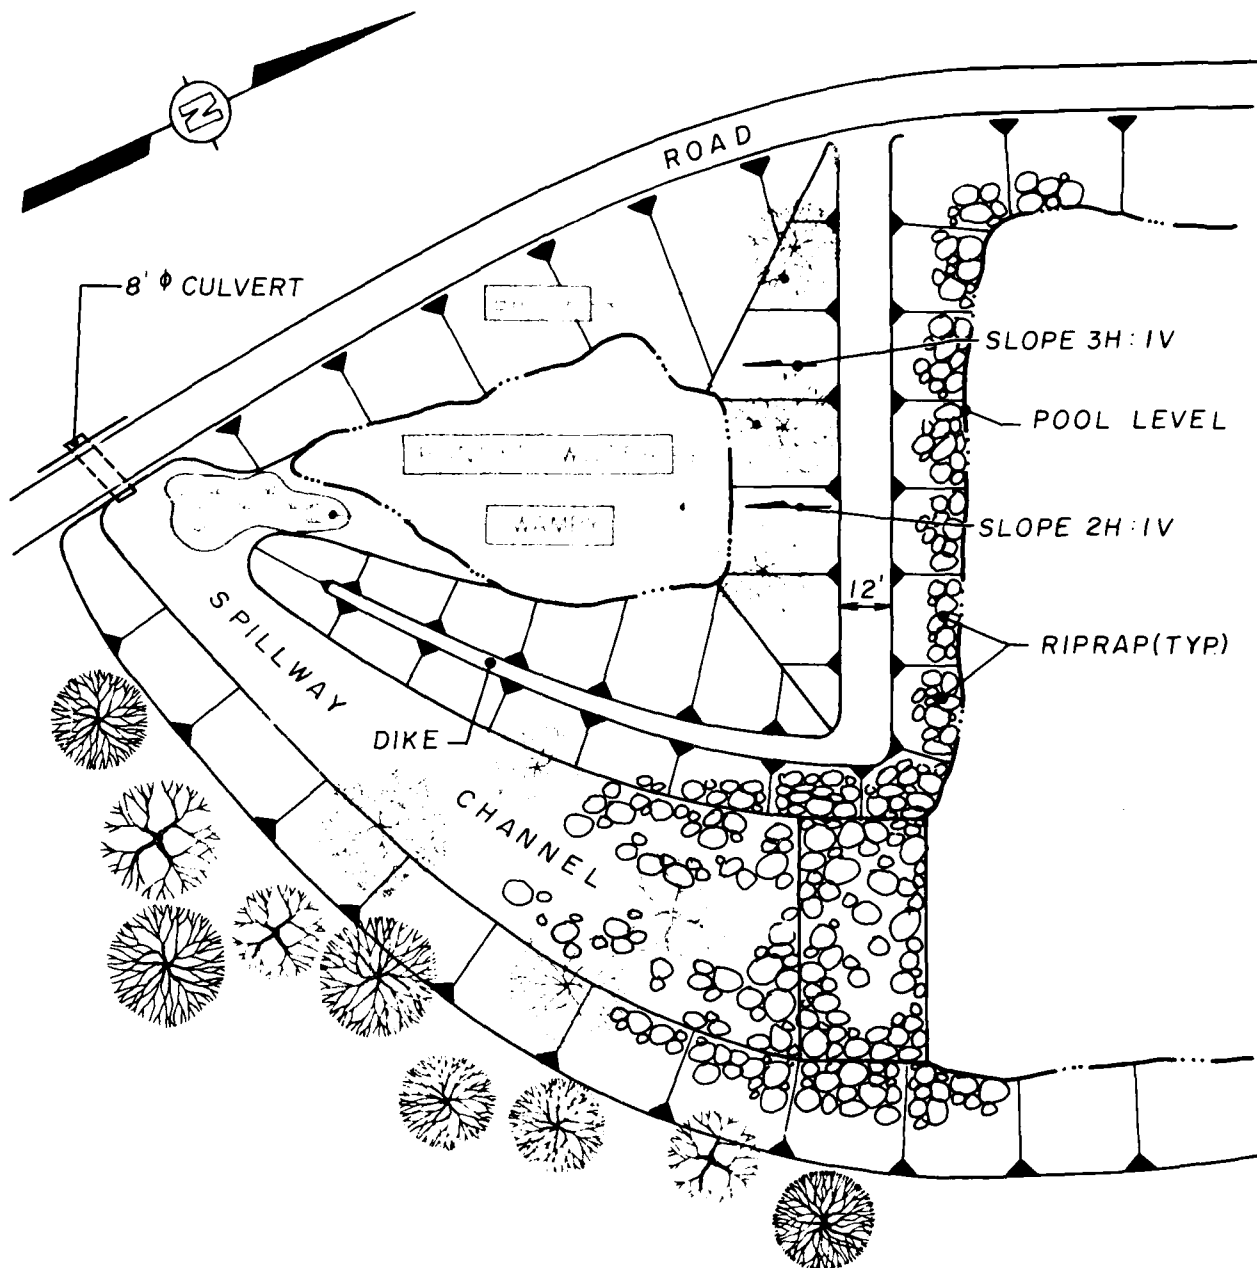
The crest of the dam was surveyed relative to the spillway crest elevation and it was found that approximately two-thirds of the embankment is approximately 1.0 foot below the design crest level. The dam crest profile is illustrated in Plate 5. The downstream slope of the dam was surveyed and found to be varying between 3 horizontal to 1 vertical and 2 horizontal to 1 vertical.

POOL LEVEL AT DATE OF INSPECTION:
 ~1 FT. BELOW SPILLWAY CREST
